# PowerSpan II™ Device Errata and Design Notes

80A1010\_ER001\_13

November 4, 2009

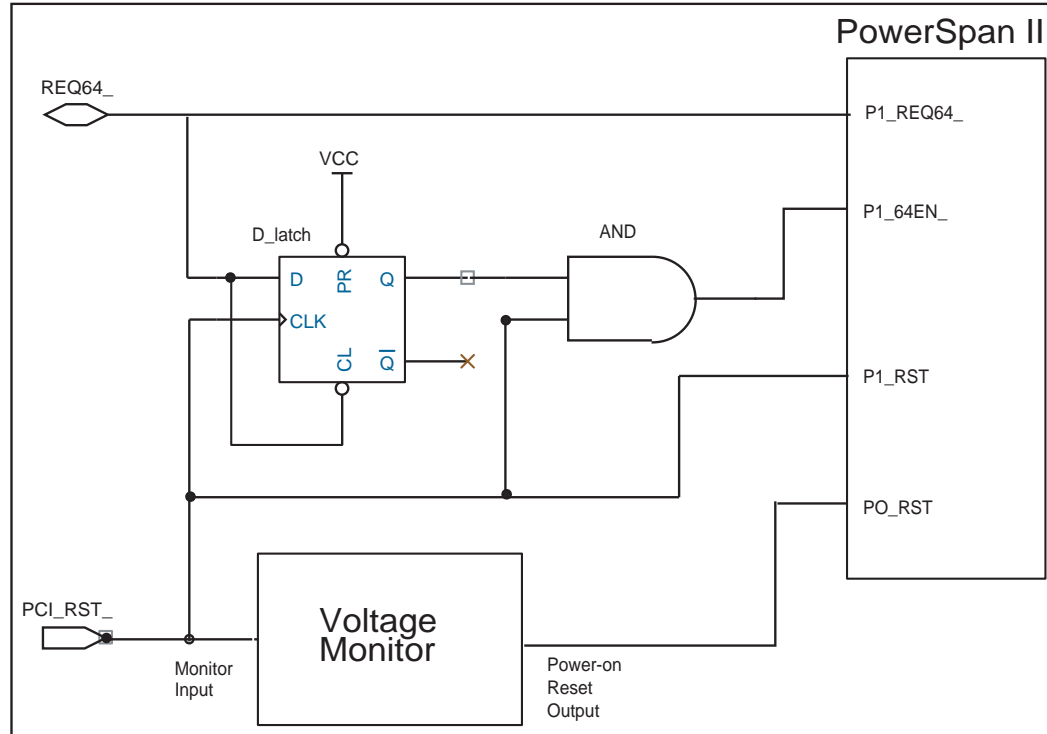
Figure 1: Logic Required to Delay Deasserting PO\_RST\_ to PowerSpan II

A customer used PowerSpan II in a PCI adapter card application. In this particular application, PO\_RST\_ was generated by a local voltage monitor device, while P1\_CLK was provided by the system controller board through the backplane. Under certain power-up events, P1\_CLK only became stable after the local PO\_RST\_ was deasserted because of different power ramping between the adapter card (containing PowerSpan II) and the system controller card. As a result of the application violating the clock and reset timing restrictions, the PowerSpan II PCI interface does not claim any transactions after reset.

By generating PO\_RST\_ off of PCI\_RST\_, there is a chance that the PowerSpan II will be unable to latch the state of the REQ64\_ signal on deassertion of PCI\_RST\_. Therefore, an external D-Latch is used to capture the state of REQ64\_ to determine the width of the bus (see [Figure 1](#)). The purpose of the asynchronous clear on D-latch is to prevent potential bus contention on the REQ64\_ signal which is driven by PowerSpan II on the deassertion of P1\_RST\_ in a 32-bit system. The P1\_64EN\_ signal, which is originally used for CompactPCI Hot Swap applications, is used here to tell the PowerSpan II if this is a 32 or 64-bit application. The AND gate is AND-ing the output of D-latch with PCI\_RST\_ to ensure the P1\_64EN\_ is low when the D-latch power-up with uncertain output.

Each PCI\_RST\_ assertion leads to a corresponding assertion on PO\_RST\_. Therefore, the PowerSpan II Multiplex System Pin Mode Power-up option’s timing must be met with each toggle of the PCI\_RST\_ signal.

If the external glue logic shown in Figure 1 is implemented by a CPLD, make sure the CPLD output and Flip-flop state are not affected by any reset.

This work-around only applies to designs where PowerSpan II is in a PCI adapter card and is configured for a non-Hot Swap environment. Normally in this scenario, the PCI bus width is indicated by P1\_REQ64\_ signal (P1\_64EN\_ is pulled high). For designs where PowerSpan II is in a PCI host card or it is configured for a Hot Swap environment, the circuit shown in Figure 1 must not be used.

The proposed work-around to this situation is to delay deasserting PO\_RST\_ to PowerSpan II until the host deasserts the PCI\_RST\_ signal. Since the PCI\_CLK is an output from the system controller along with PCI\_RST\_, the negation of PCI\_RST\_ implies the PCI\_CLK is stable. The local voltage monitor uses PCI\_RST\_ to make sure that the PCI\_CLK is stable before the deassertion of PO\_RST\_. A possible implementation of this circuit is shown in [Figure 1](#).

Figure 1 shows the logic required to delay deasserting PO\_RST\_ to PowerSpan II until the host deasserts the PCI\_RST\_ signal.
